REPORT OF PRELIMINARY GEOTECHNICAL INVESTIGATION

**PROPOSED MASON RESIDENCE
SUNSET CLIFFS BOULEVARD
SAN DIEGO, CALIFORNIA**

August 25, 2023

CWE 2230146.01

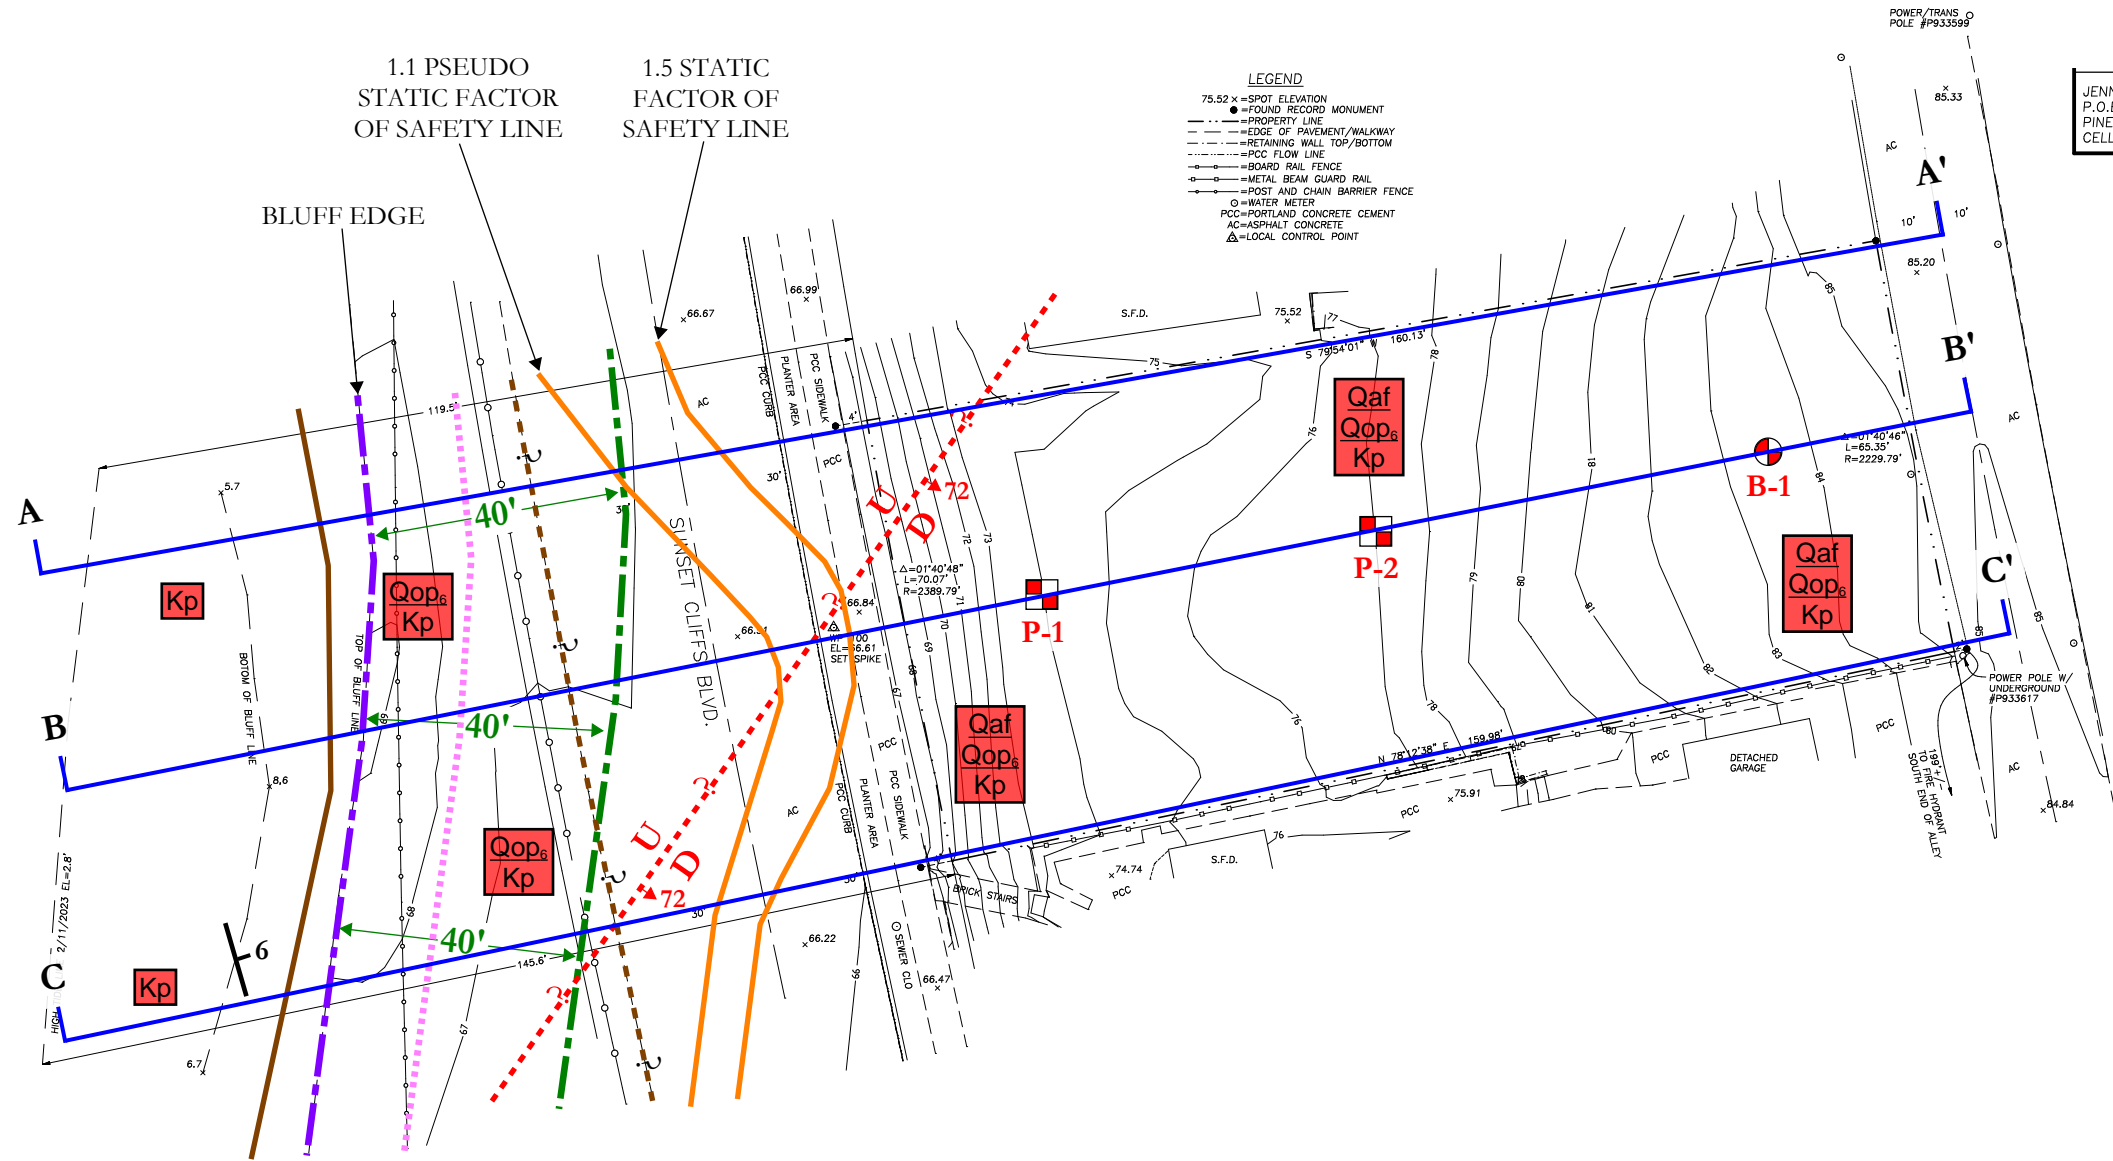
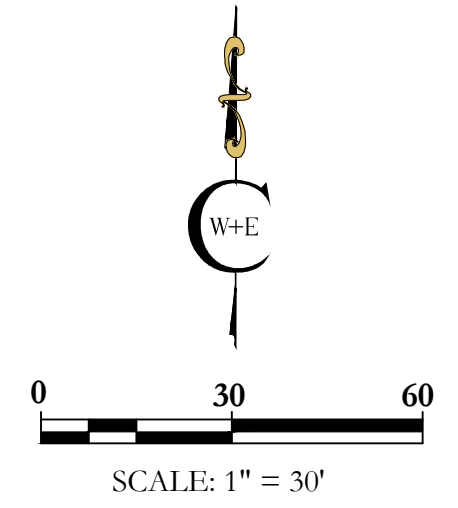
MASON RESIDENCE, APN 532-010-06-00 SUNSET CLIFFS BOULEVARD, SAN DIEGO, CA	
DATE: MAY 2023	REPORT NO.: 2230146.01
BY: JMM	PLATE NO.: 1A

This greatest of these mean annual rates of retreat (0.20 feet/year) corresponds to approximately 15 feet of bluff edge erosion over the next 75 years. This amount of potential bluff edge erosion is less than the minimum bluff edge setback recommended herein. A line depicting the projected bluff edge recession over a period of the next 75 years is presented on Plate Nos. 1A and 1B of this report.

EXISTING SITE PLAN AND GEOLOGIC MAP

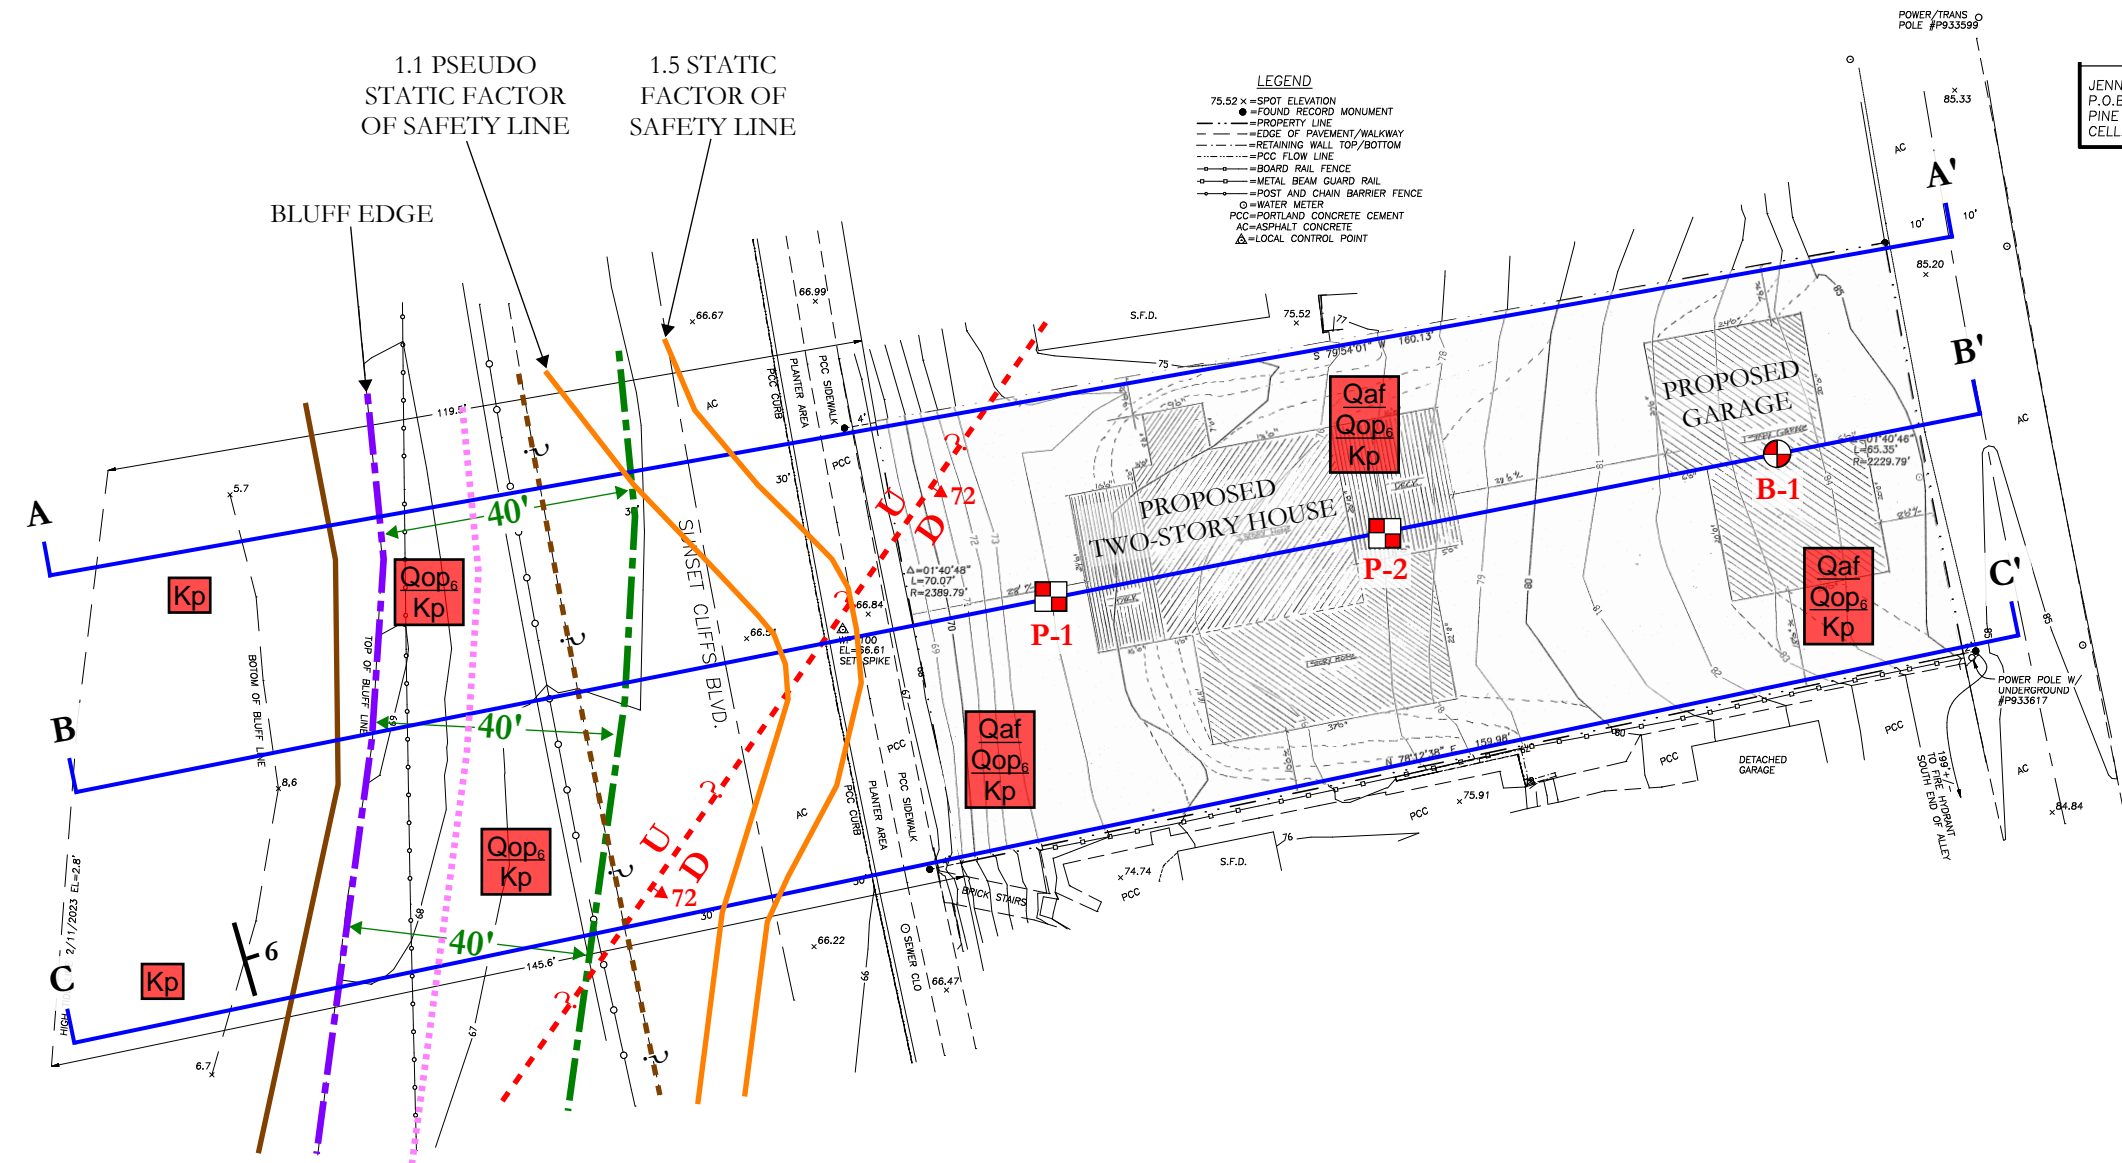
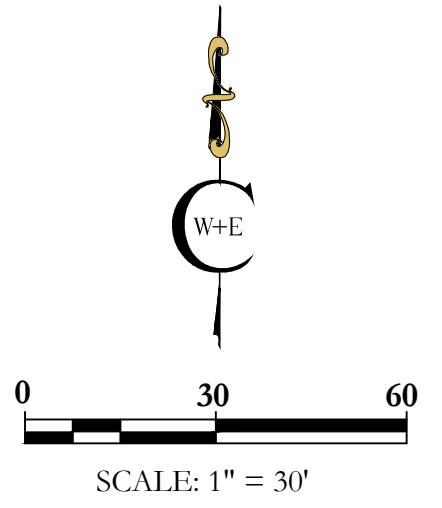
MASON RESIDENCE, APN 532-010-06-00 SUNSET CLIFFS BOULEVARD, SAN DIEGO, CA	
DATE: MAY 2023	REPORT NO.: 2230146.01
BY: JMM	PLATE NO.: 1B

PROPOSED SITE PLAN AND GEOLOGIC MAP

RECOMMENDED BLUFF TOP SETBACK: Based on the results of our quantitative bluff stability analyses, the fact that our conservative estimation of future erosion of the edge of bluff to the west of the site is less than the City's standard setback, and the requirements of the City of San Diego Municipal Code, it is

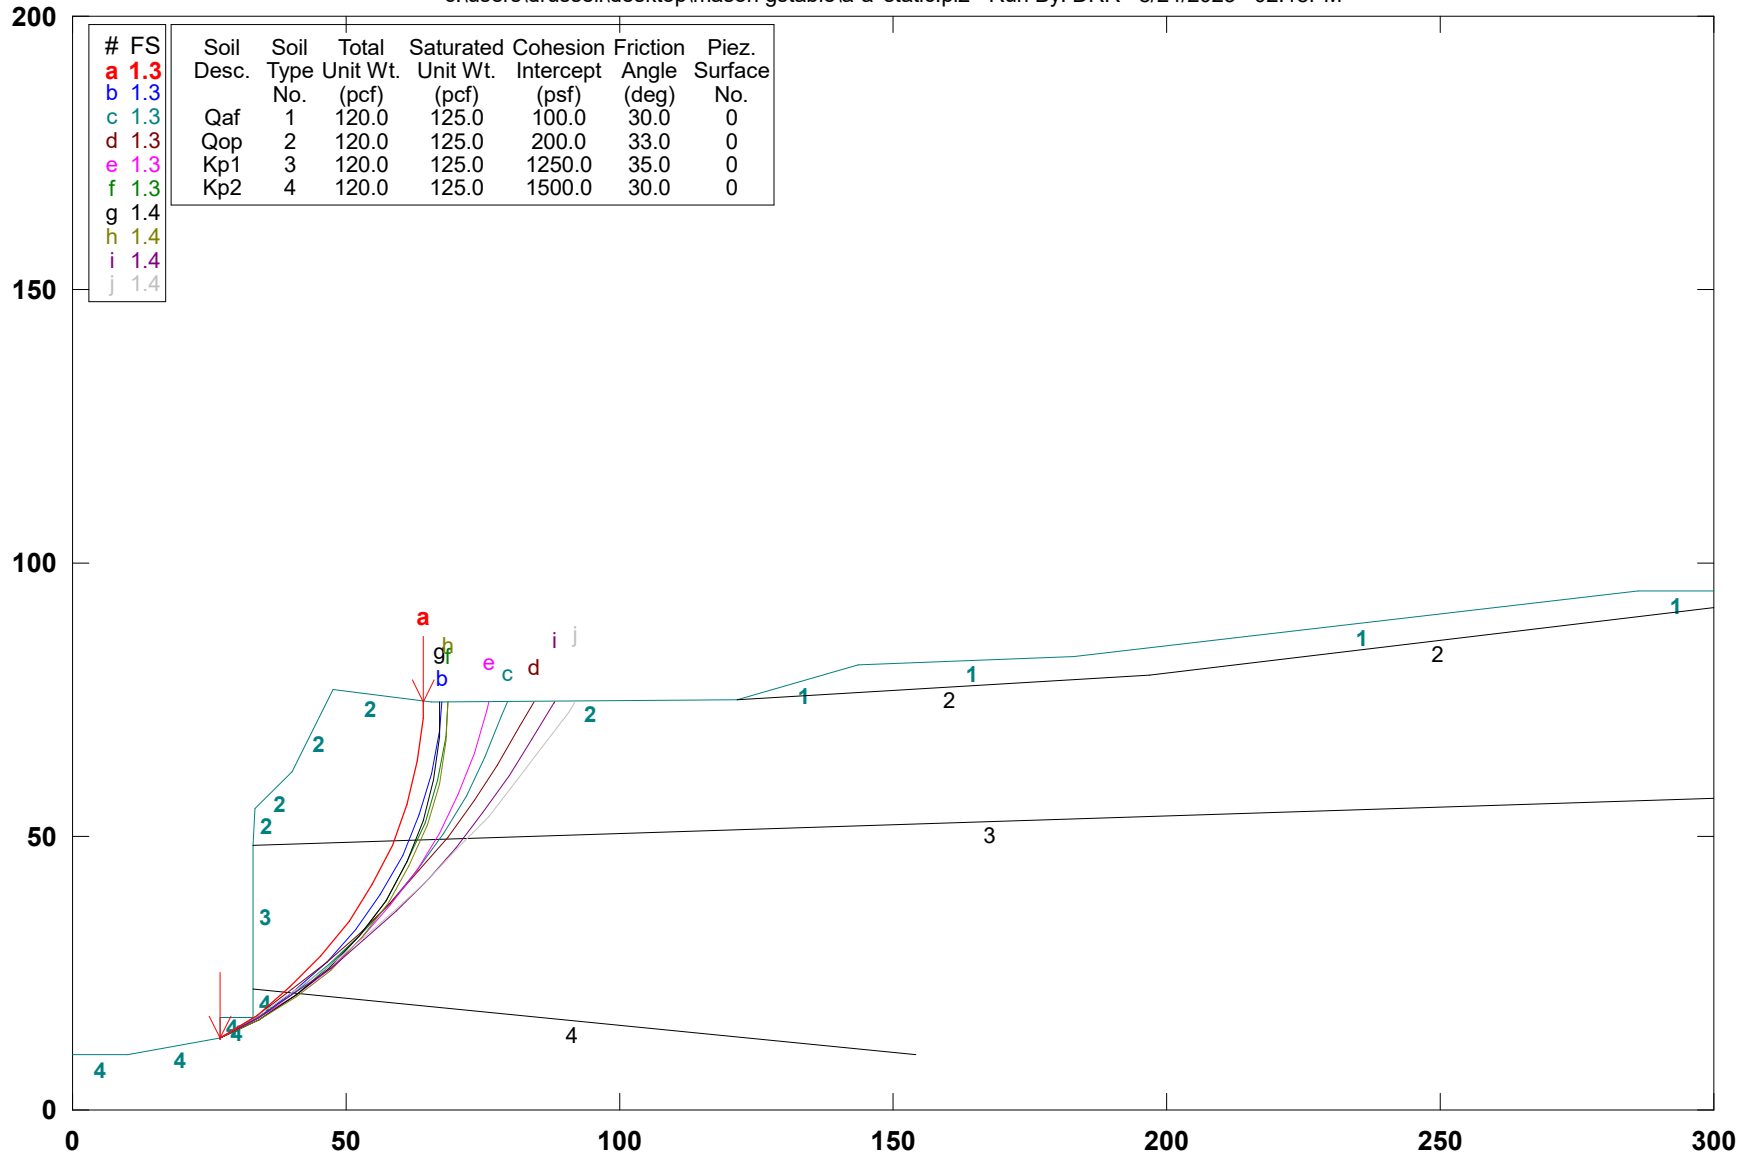
Mason Residence CWE 2230146.01 A-A' Static

Our analyses indicate that the lowest static factors-of-safety against bluff failures of the existing bluff to the west of site are approximately 1.3, 1.0, and 1.0 along cross sections A-A', B-B', and C-C' respectively. It should be noted that our analyses modelled all portions of the bluff face seaward of the small undercut along its base as being removed. It should also be recognized that these results indicate that the strength parameters modelled in our analyses were conservatively estimated.

GSTABL7 v.2 FSmin=1.3

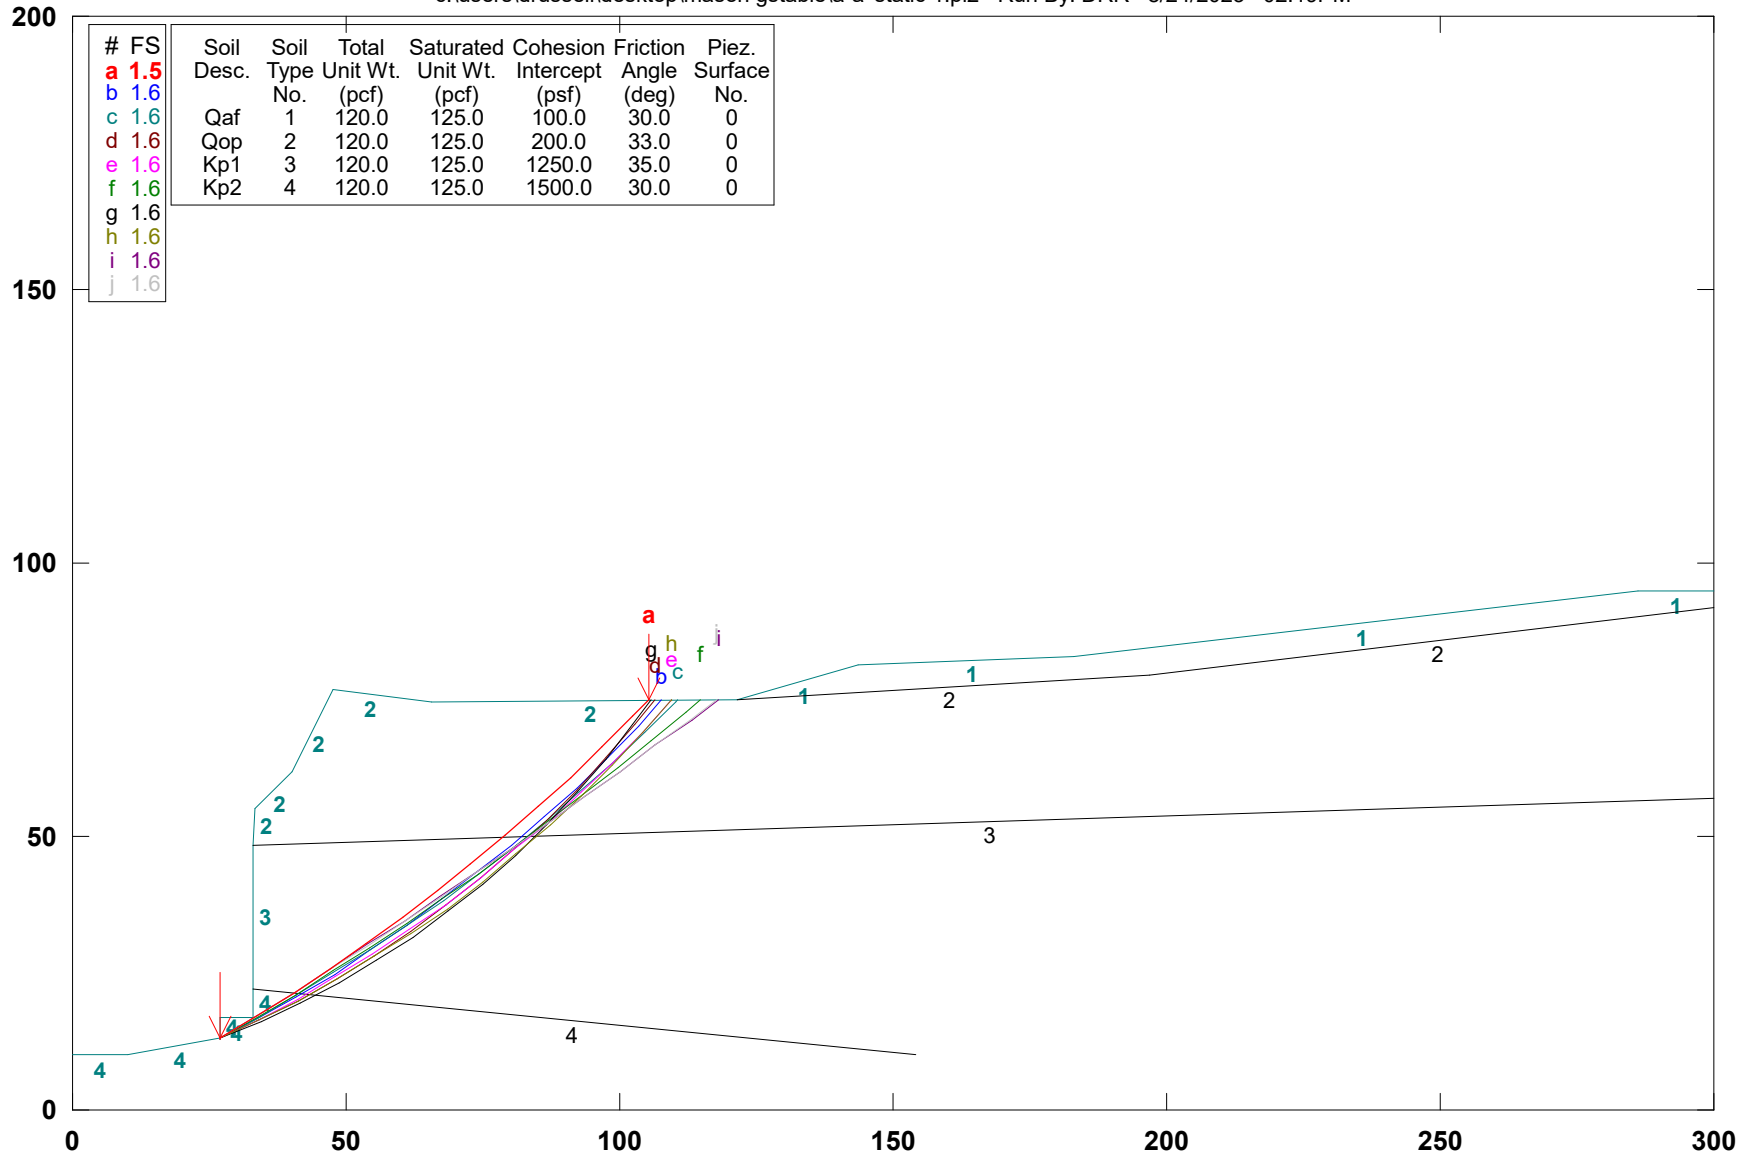
Mason Residence CWE 2230146.01 A-A' Static to 1.5

Following the initial analyses, additional stability analyses were performed to determine the locations along cross sections A-A', B-B', and C-C' where minimum factors-of-safety of 1.5 or higher against failure are exhibited. Our analyses demonstrate that a minimum factor-of-safety of 1.5 or greater is demonstrated along A-A', B-B', and C-C' at distances of 105 feet, 125 feet, and 110 feet from the western edges of A-A', B-B', and C-C', respectively. Plate Nos. 1A and 1B of this report depict where a minimum factor-of-safety of 1.5 or greater are demonstrated along the edge of bluff in the vicinity of cross sections A-A', B-B', and C-C'.

GSTABL7 v.2 FSmin=1.5
 Safety Factors Are Calculated By The Modified Bishop Method

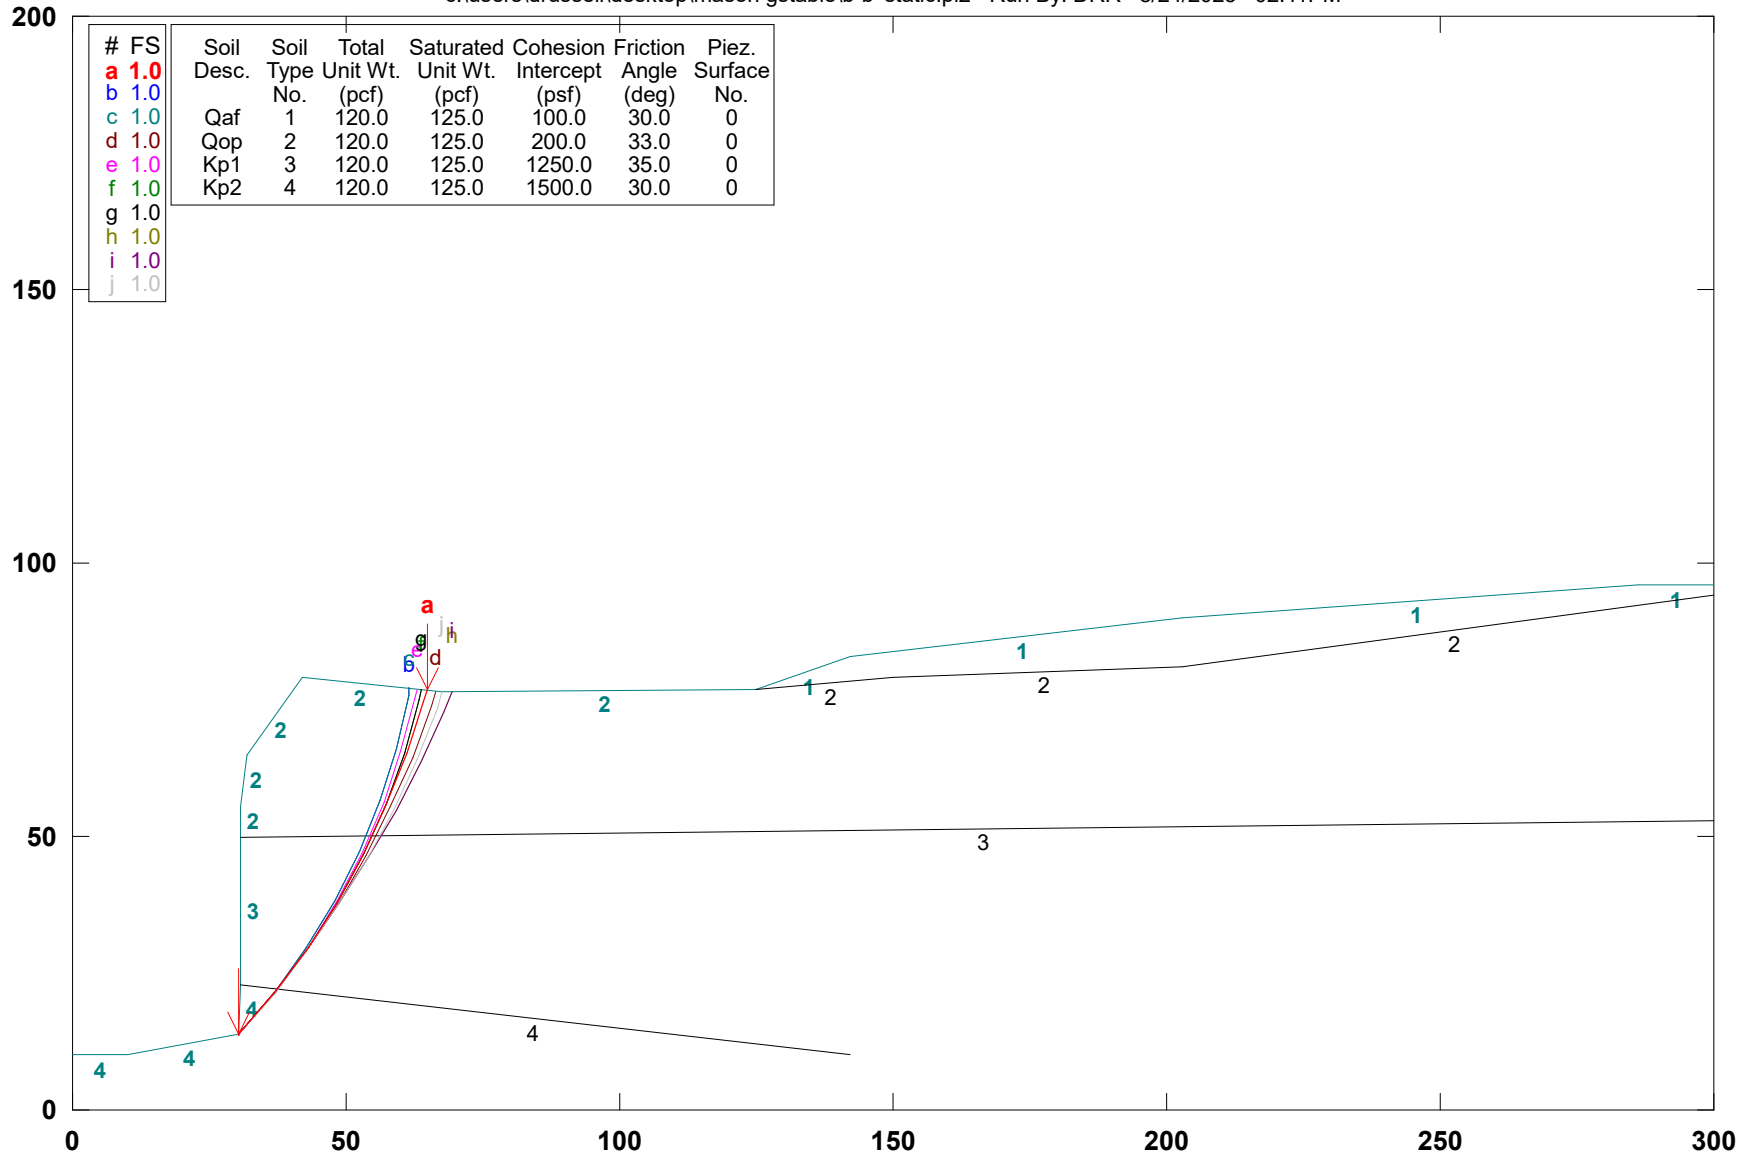
Mason Residence CWE 2230146.01 B-B' Static

GSTABL7 v.2 FSmin=1.0
 Safety Factors Are Calculated By The Modified Bishop Method

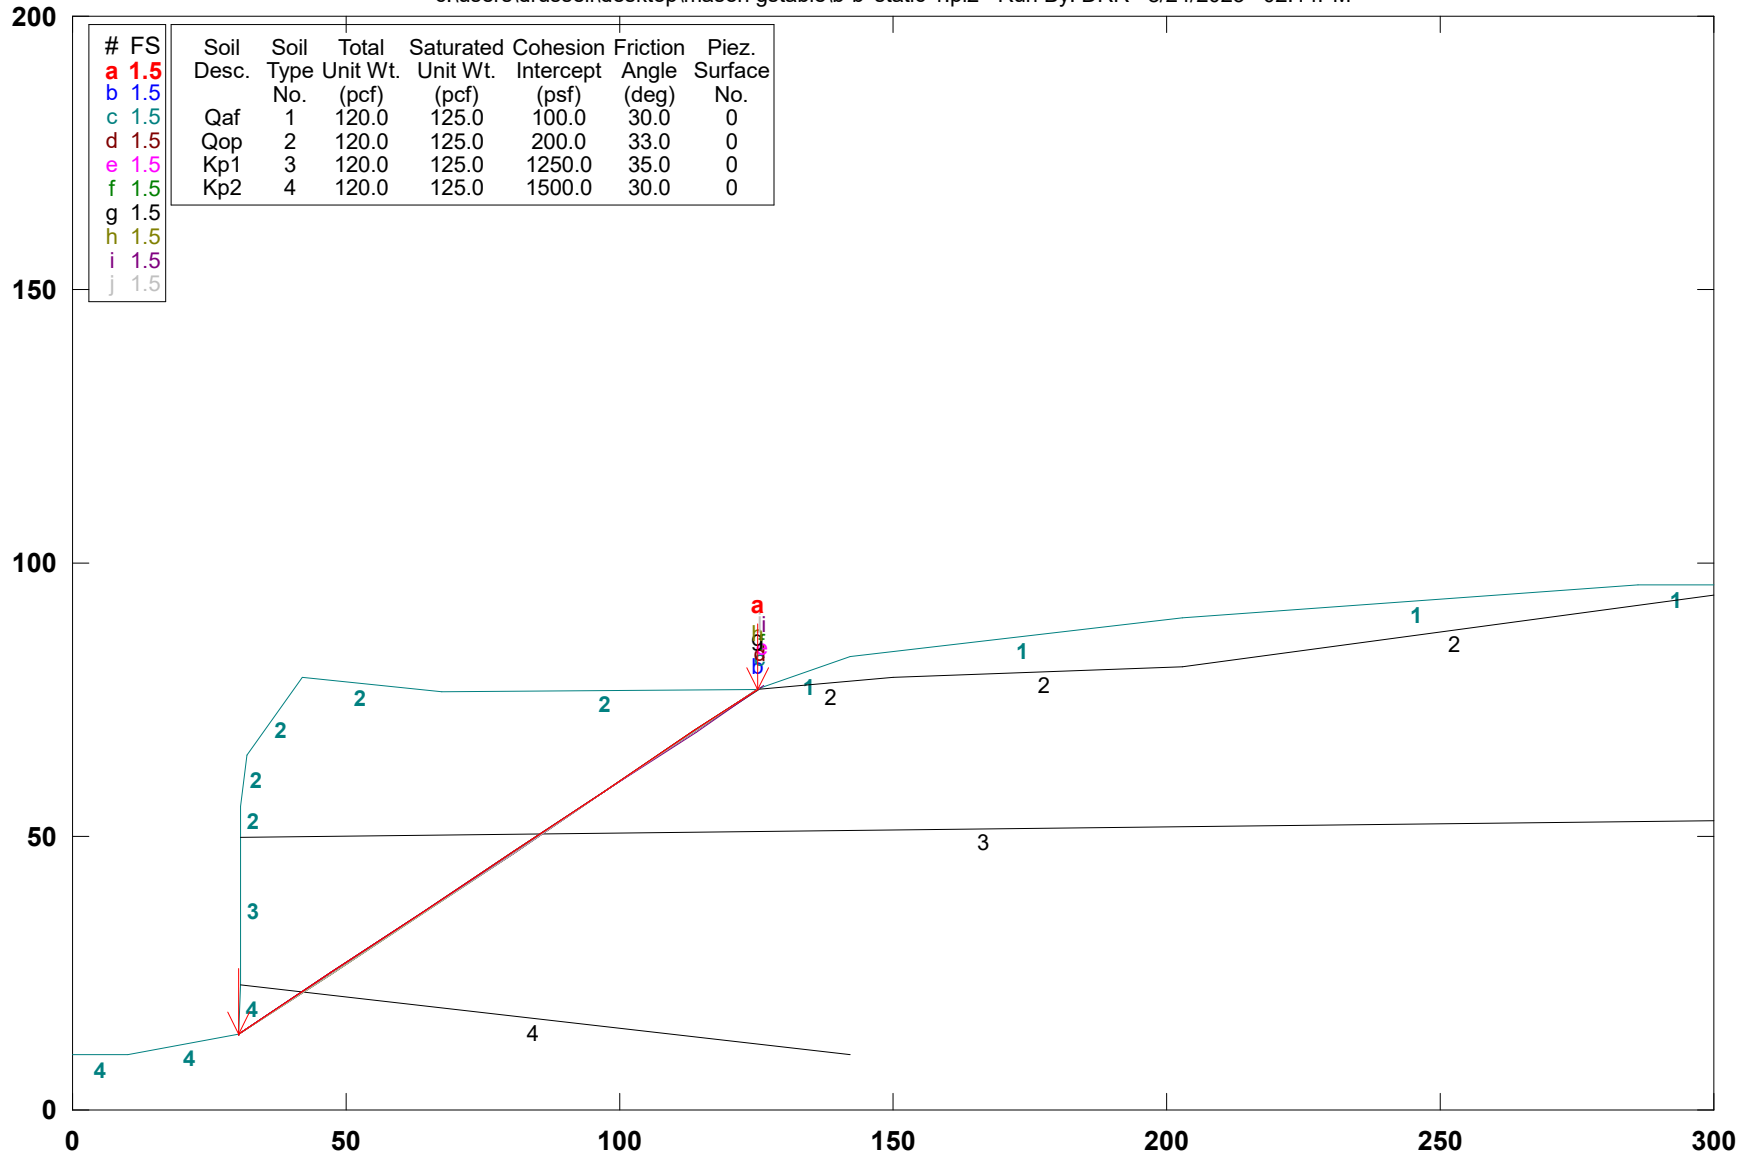
Mason Residence CWE 2230146.01 B-B' Static TO 1.5

GSTABL7 v.2 FSmin=1.5

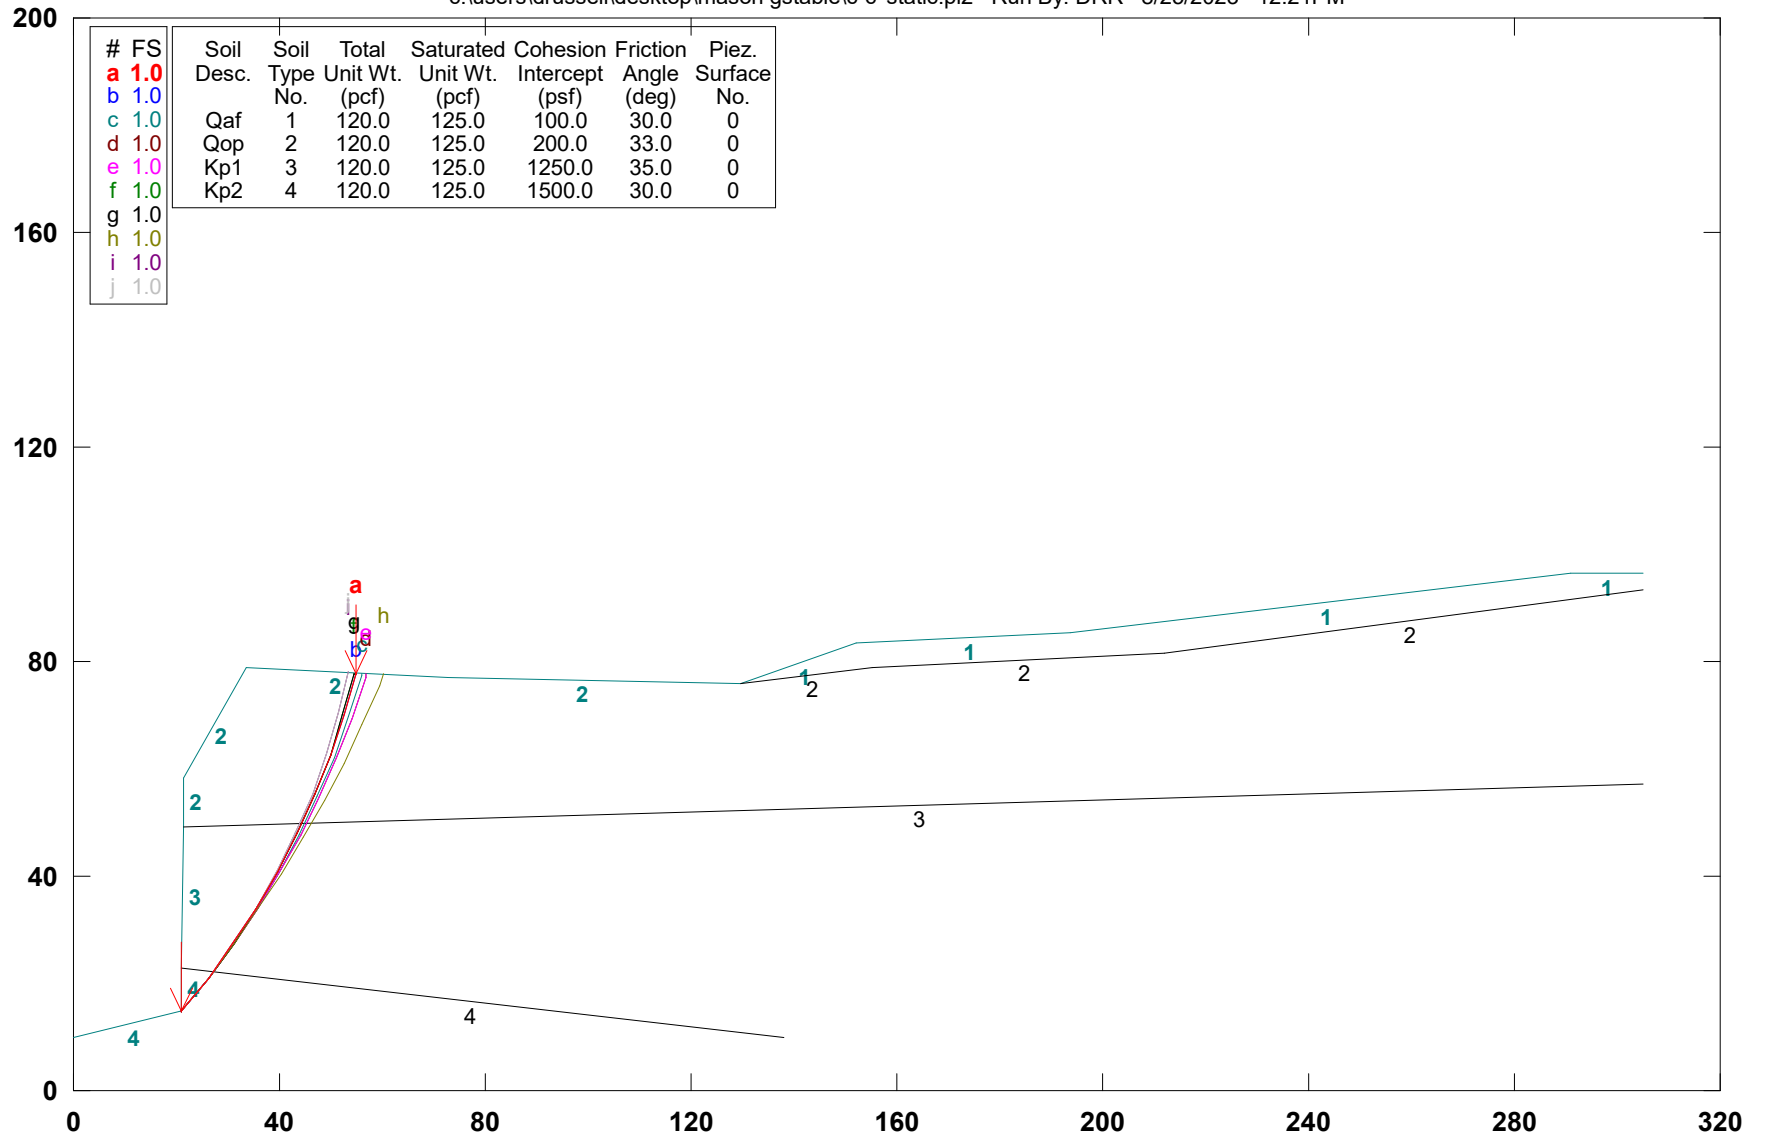
Mason Residence CWE 2230146.01 C-C' Static

GSTABL7 v.2 FSmin=1.0

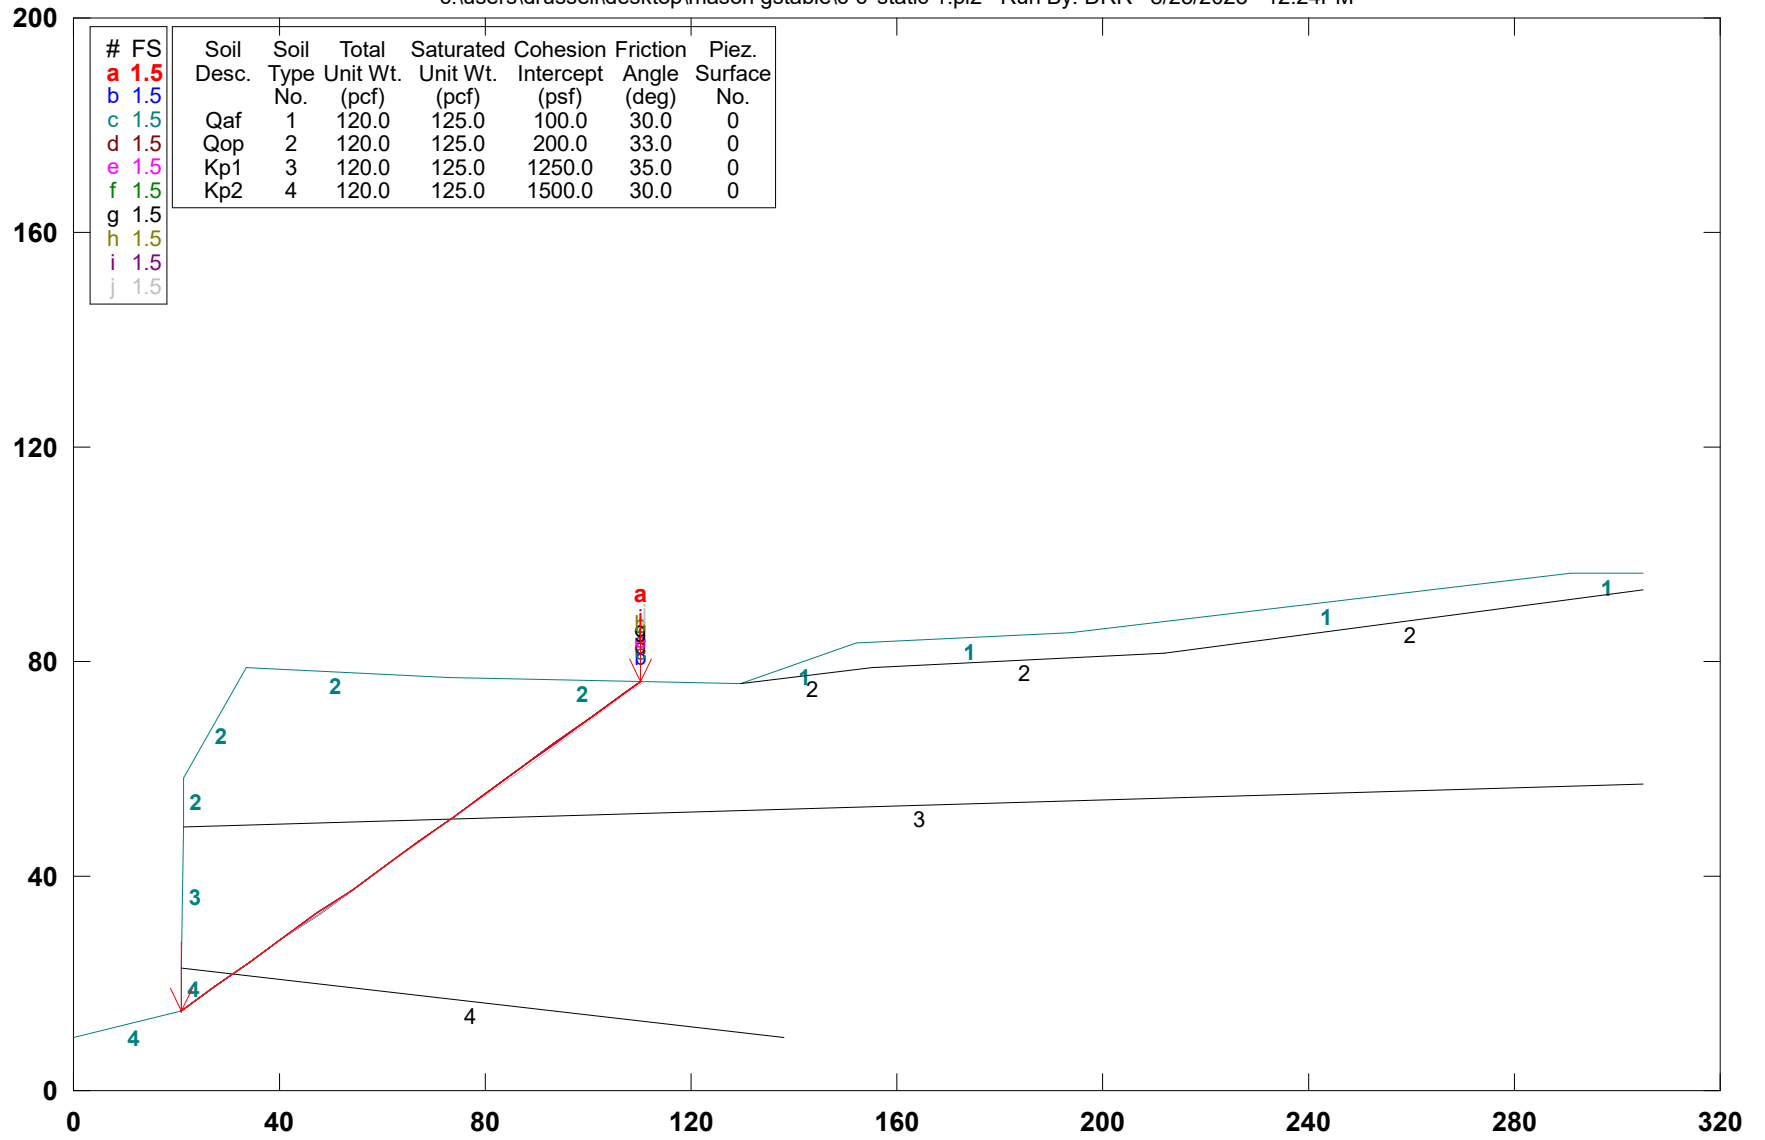
Mason Residence CWE 2230146.01 C-C' Static to 1.5 FOS

GSTABL7 v.2 FSmin=1.5
